building performance centre

**ACOUSTIC NOISE
MEASUREMENTS OF AIR
SOURCE HEAT PUMPS
(EE0214)**

September 2011

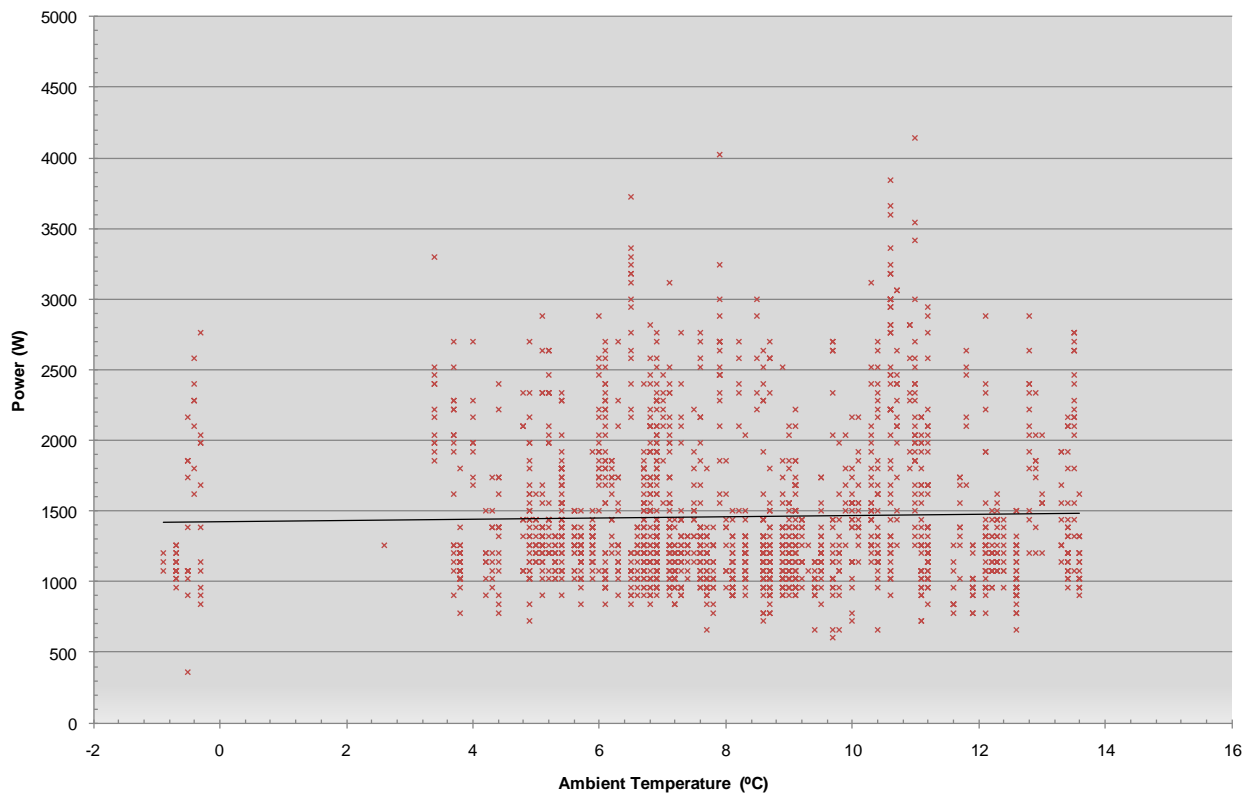
Figure 5-4. 486 Stroud, Power Consumption vs Ambient Temperature

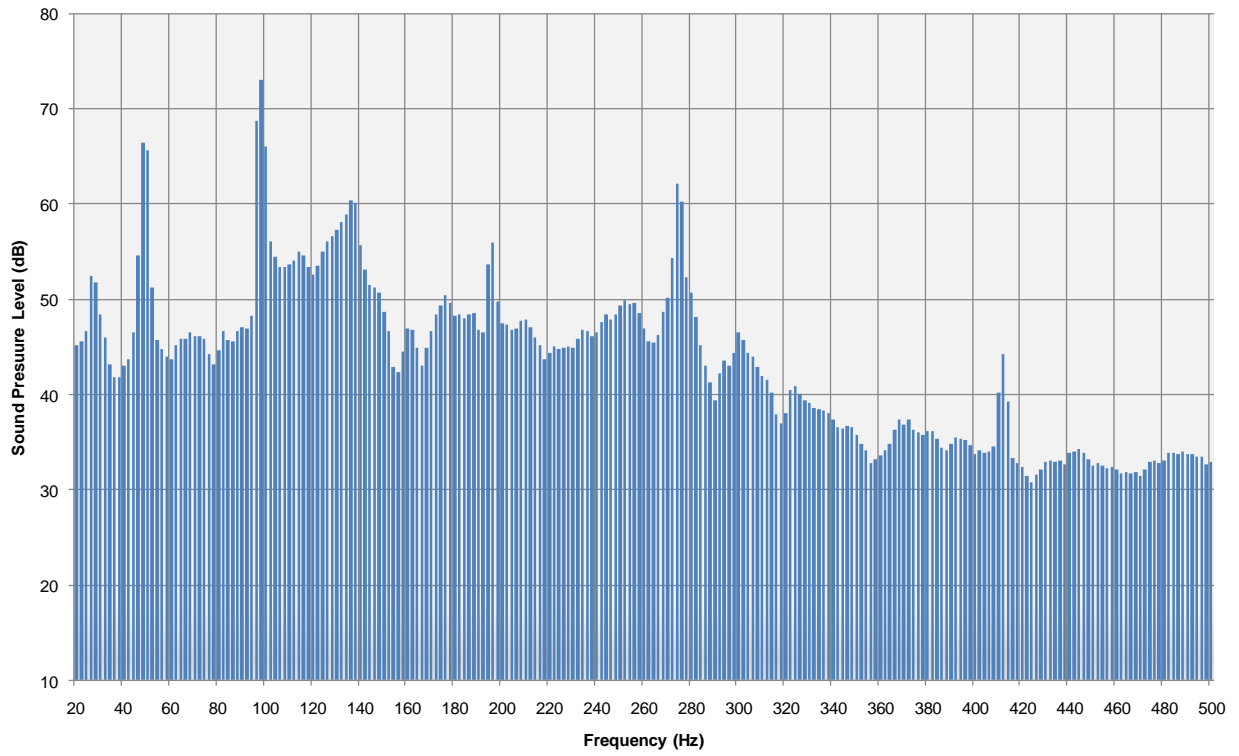
- 5.2.16. For the frequency analysis, a Fast Fourier Transform (FFT) of the signal was performed, averaged over a representative one minute period at a frequency resolution of 2 Hz. The resulting frequency spectrum for the ASHP operating under normal conditions is given in Figure 5-13, with that for the defrost cycle presented in Figure 5-14.

Figure 5-13. 440 Fylde, Sound Pressure Level Frequency Spectrum (Normal Operation)

5.2.17. Tonal analysis of the frequency spectra shown in Figure 5-13 and Figure 5-14 has been undertaken in accordance with the Joint Nordic Method (v2). The resulting tonal assessments are presented in Figure 5-16 and Figure 5-16, showing that the tones identified within the spectrum for normal operation would lead to a **2 dB tonal penalty**. During the defrost cycle, the tonal assessment indicates that a **6 dB tonal penalty** would be appropriate.

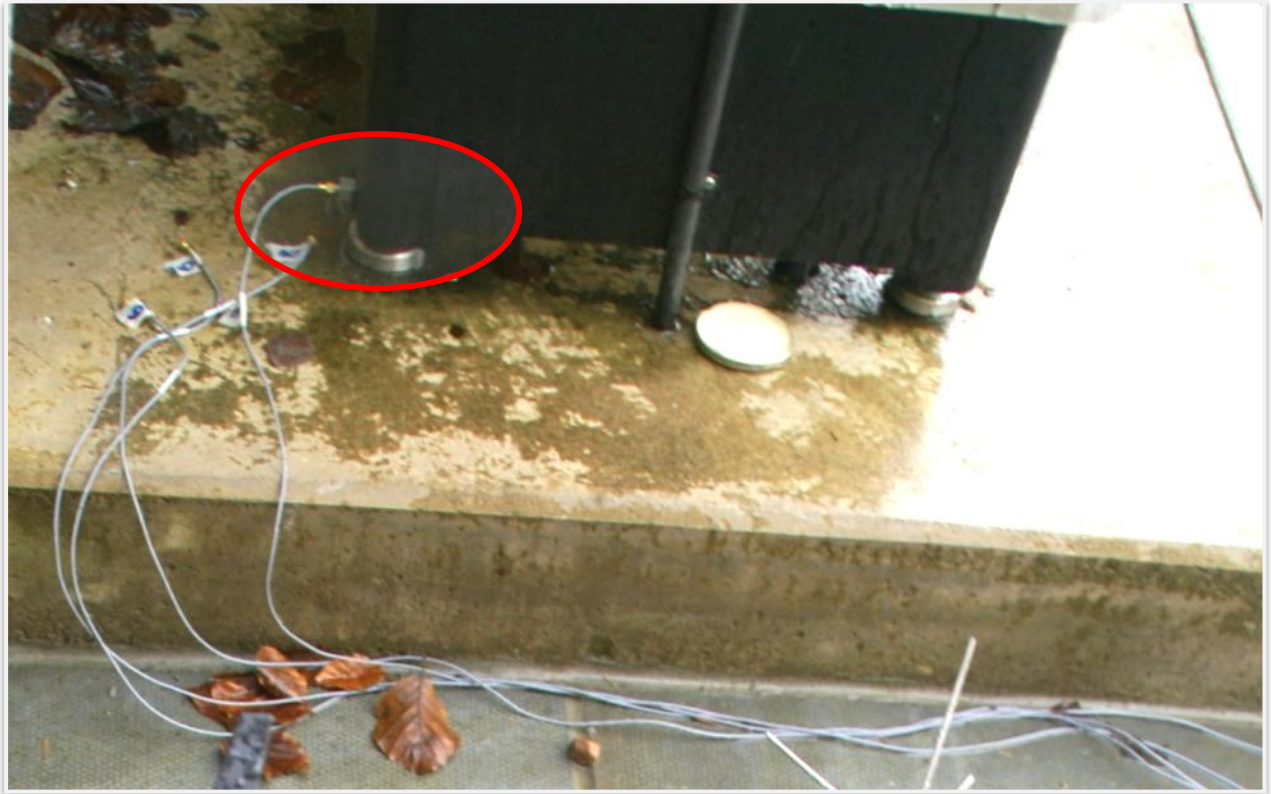
- 5.3.3. The 5 Channel PULSE system was used at this site.
- 5.3.4. The ASHP was located on hard, reflective ground.
- 5.3.5. An accelerometer was fixed to the unit casing, as shown in Picture 5-8, using cyanoacrylate cement. However, subsequent analysis of the results has shown that a representative signal was not present in the data, which could occur, for example, in the event of cable failure. No meaningful vibration data was therefore measured.

Picture 5-8. 418 Central Buchan, Casing-mounted Accelerometer

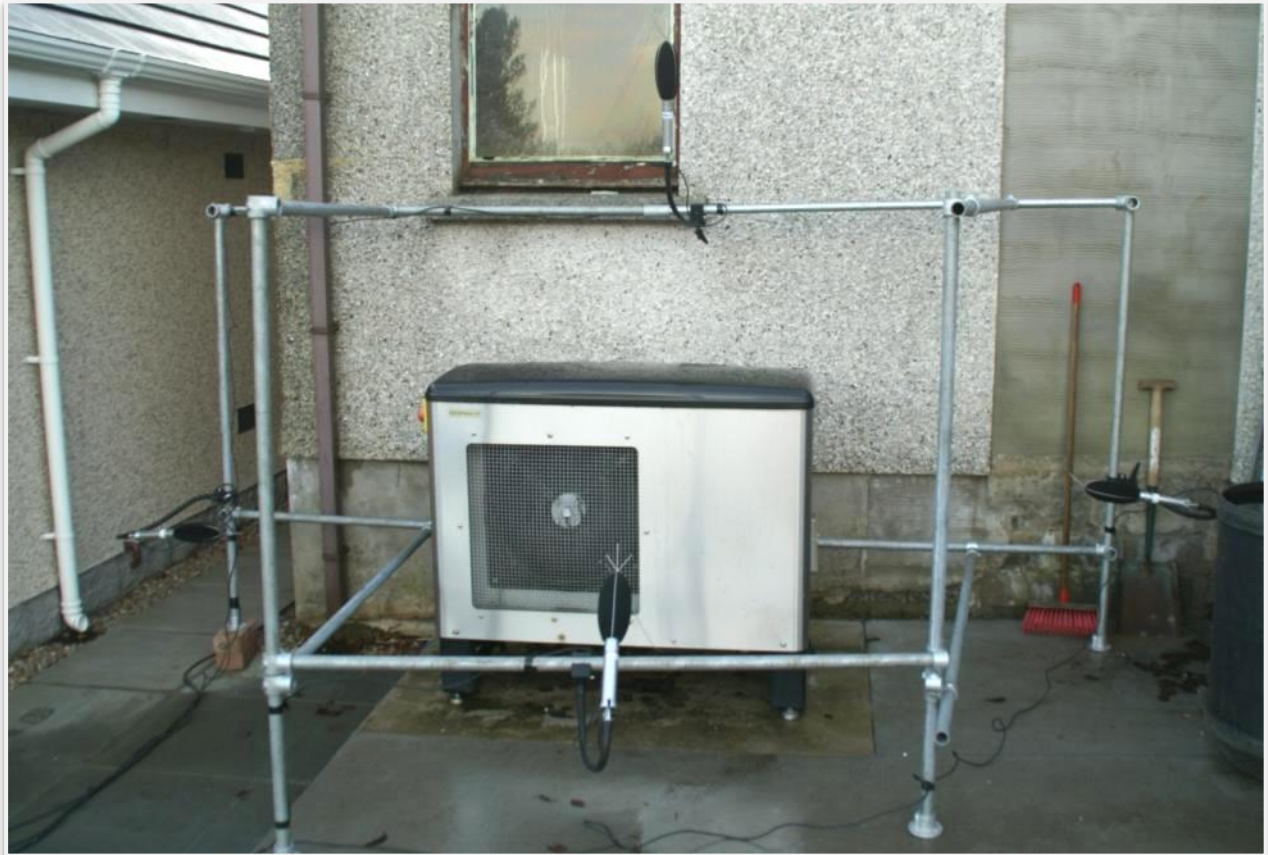
- 5.3.6. Four microphones were used, mounted on temporary framework as shown in Picture 5-9. All microphones were positioned 1 m from the ASHP casing.

Picture 5-9. 418 Central Buchan, ASHP and Microphone Arrangement

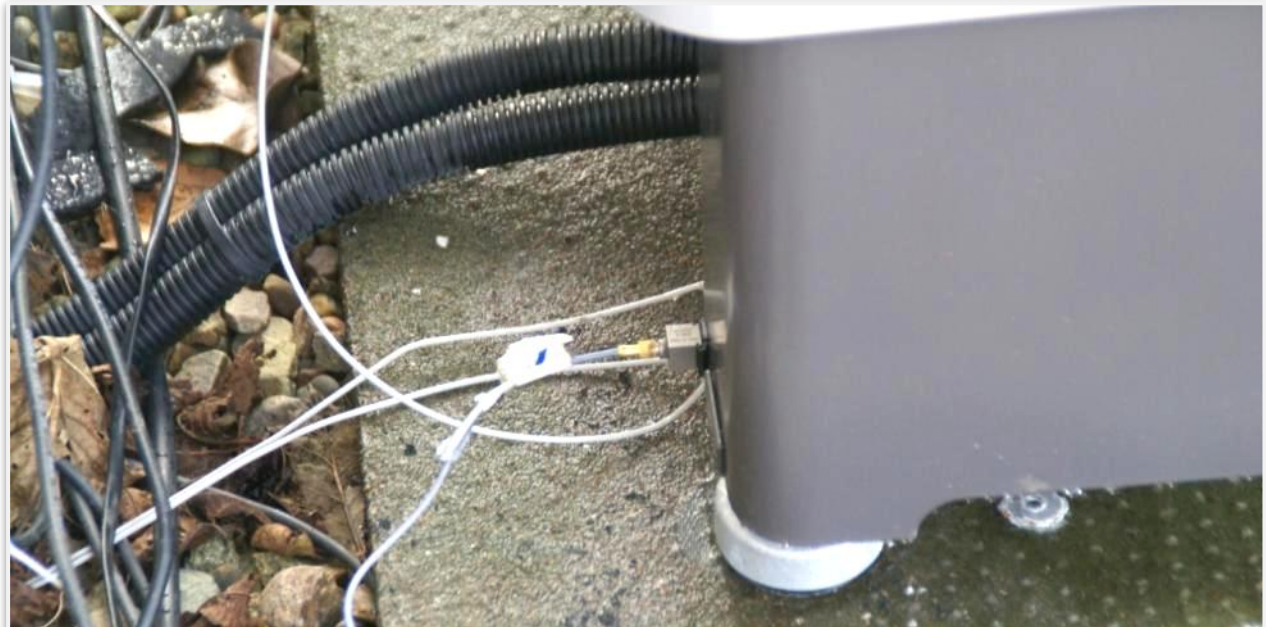
- 5.5.4. The 5 Channel PULSE system was used at this site.
- 5.5.5. The ASHP was located on reflective ground, and in front of a reflective wall.
- 5.5.6. An accelerometer was fixed to the casing of the ASHP, as shown in Picture 5-13. The accelerometer was fixed to the surface using cyanoacrylate cement.

Picture 5-13. 422 Fraserburgh (Replacement), Casing-mounted Accelerometer

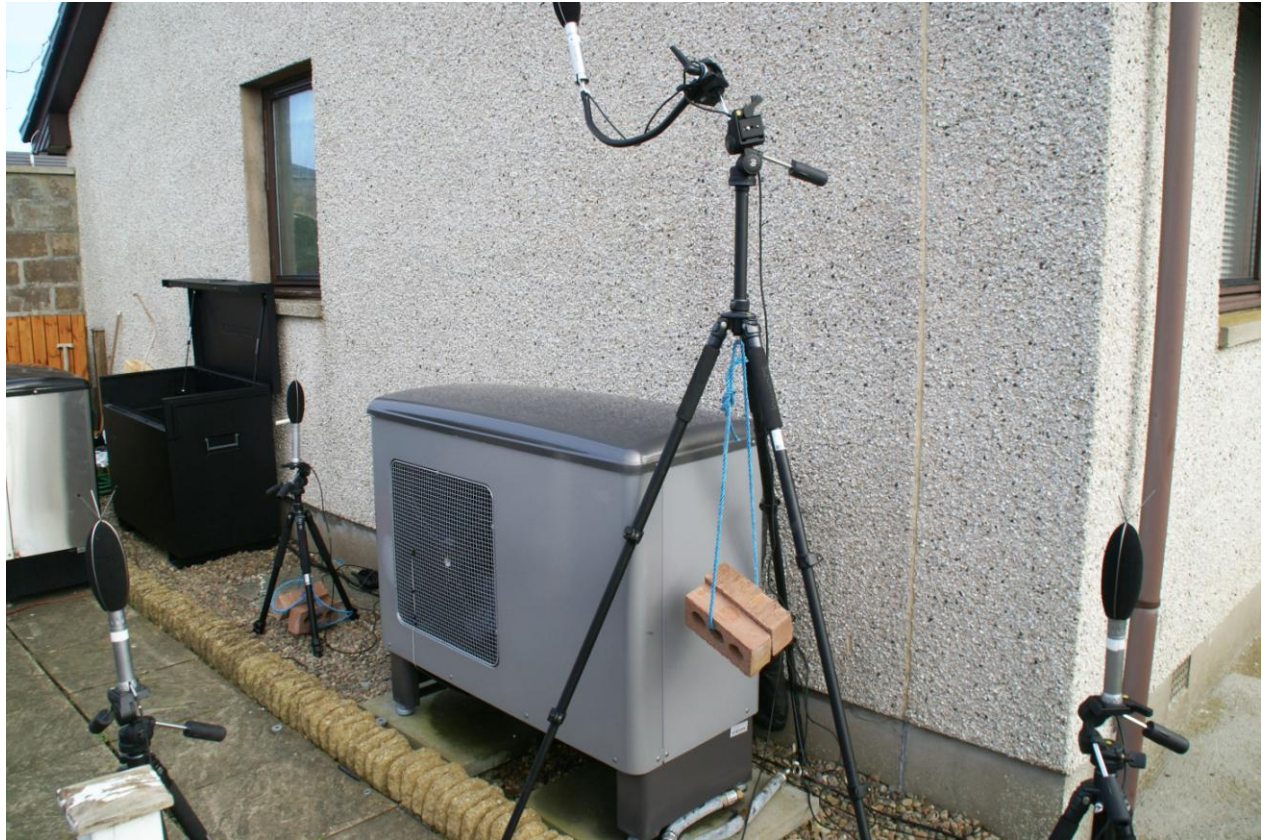
- 5.5.7. The microphones were mounted on heavy-duty tripods as shown in Picture 5-14. All microphones were positioned 1 m from the ASHP casing.

Picture 5-14. 422 Fraserburgh, Replacement ASHP and Microphone Arrangement
